# Manhole Inspection Summary

Manhole # S69K\_\_010MH

**Location** Address: **6611 Bushey St.**

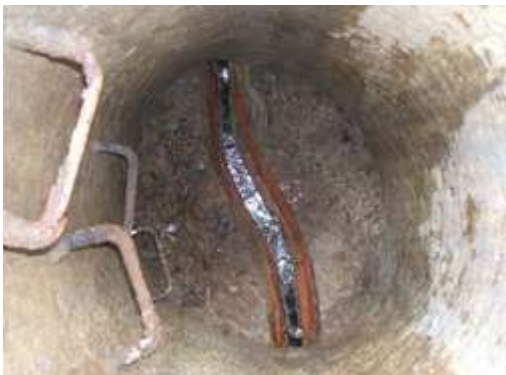
Top View

O12 at top of picture

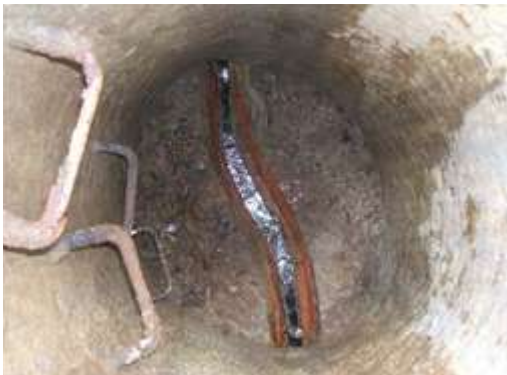
Defect 1

ground water infiltration 12 to 4 above and around the incoming 6 connection

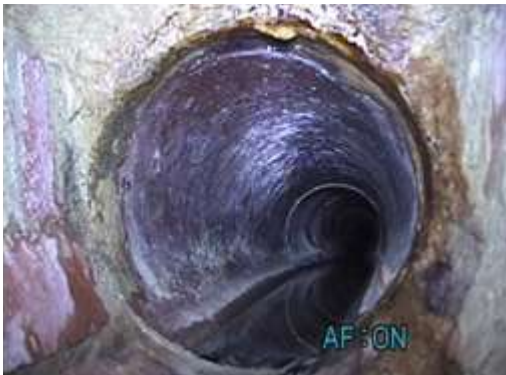
Defect 1

[dae] deposit attach encrustation 12 to 5 around the incoming 6 connection

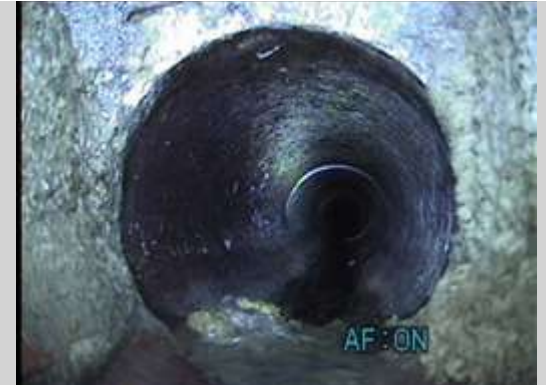
12 O'Clock Outflow

8 in. Circular Gravity Sewer  
Pipe Out @ 12 O'Clock

Pipe Height: **8.4** (in.) Rod and Bar (Angled)  
Pipe Material: **Clay** ☐ Pipe Lined  
Invert Depth: **9.21** (ft.) Flow Characteristics: **Slow**  
Deposits: ☐ None ☐ Mud ☒ **Sludge** ☐ Debris ☐ Grease  
Silt Depth: **0.25** (in.) Deposits Extent: **Light**  
Infiltration: **None** Pipe Seal Cond: **Sound**

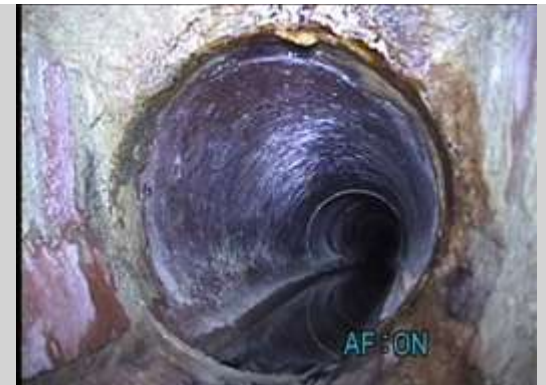
6 O'Clock Inflow

8 in. Circular Gravity Sewer  
Pipe In @ 6 O'Clock

Pipe Height: **8.4** (in.) Rod and Bar (Angled)  
Pipe Material: **Clay** ☐ Pipe Lined  
Invert Depth: **9.00** (ft.) Flow Characteristics: **Slow**  
Deposits: ☒ **None** ☐ Mud ☐ Sludge ☐ Debris ☐ Grease  
Silt Depth: (in.) Deposits Extent:  
Infiltration: **None** Pipe Seal Cond: **Sound**
